MASH Test Nos. 3-17 and 3-11 on a Non-Proprietary Cable Median Barrier

*Midwest States Regional Pooled Fund Research Program
Fiscal Years 2012 and 2014 (Years 22 and 24)
Research Project Number TPF-5(193) sup. 44 and sup. 64
NDOR Sponsoring Agency Code RFP-14-CABLE-1*

MASH TEST NOS. 3-17 AND 3-11 ON A NON-PROPRIETARY CABLE MEDIAN BARRIER

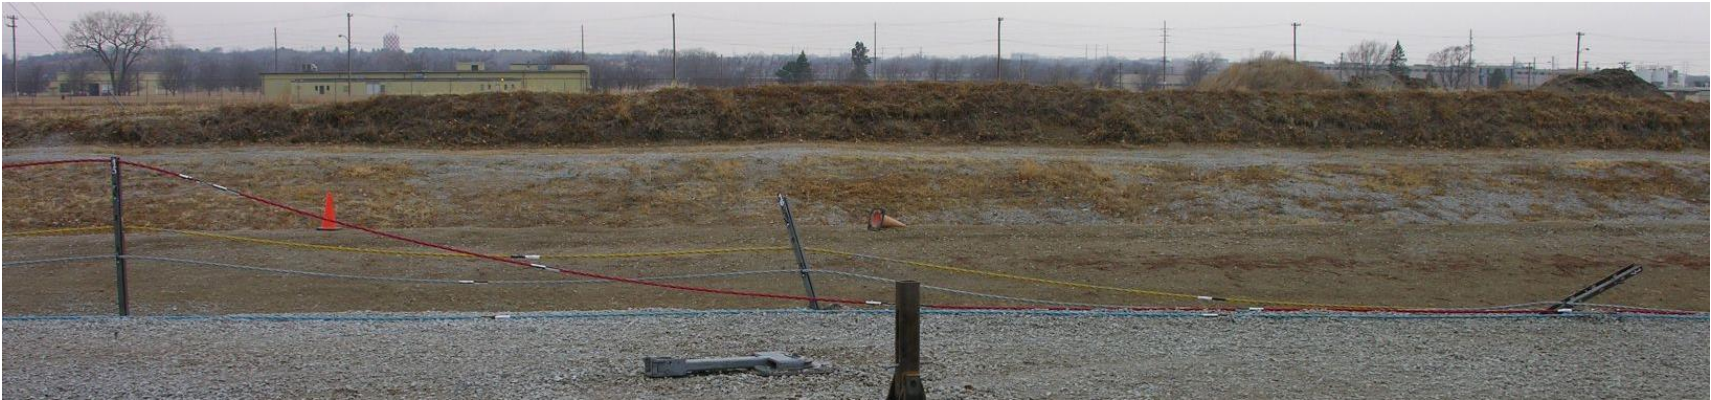
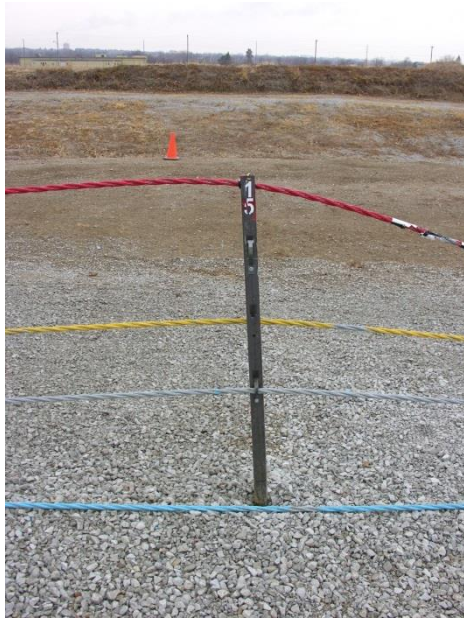
Post No. 15

Damage to the barrier was moderate, as shown in Figures 46 through 50. Barrier damage consisted of bent posts, disengaged cables, and deformed brackets. At its final resting position, the vehicle was still in contact with the cables. Cable no. 2 was on the left side and the remaining cables were on the right side.

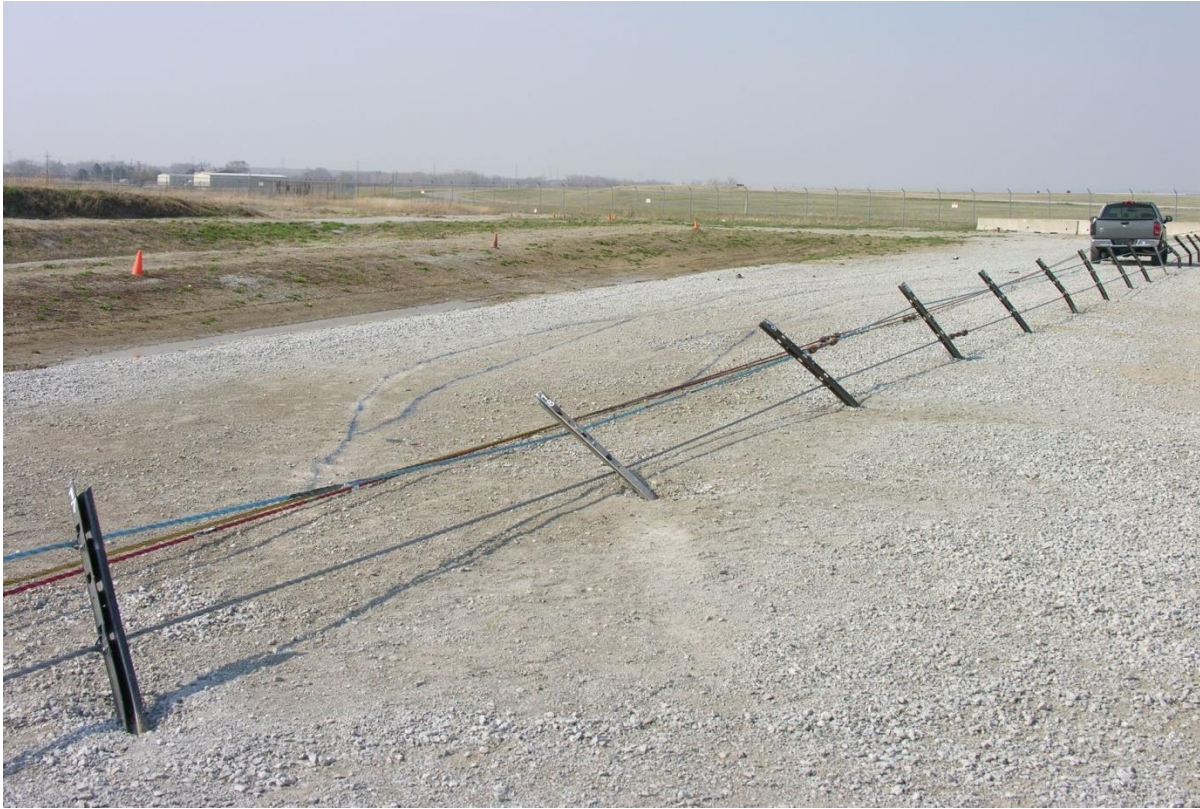
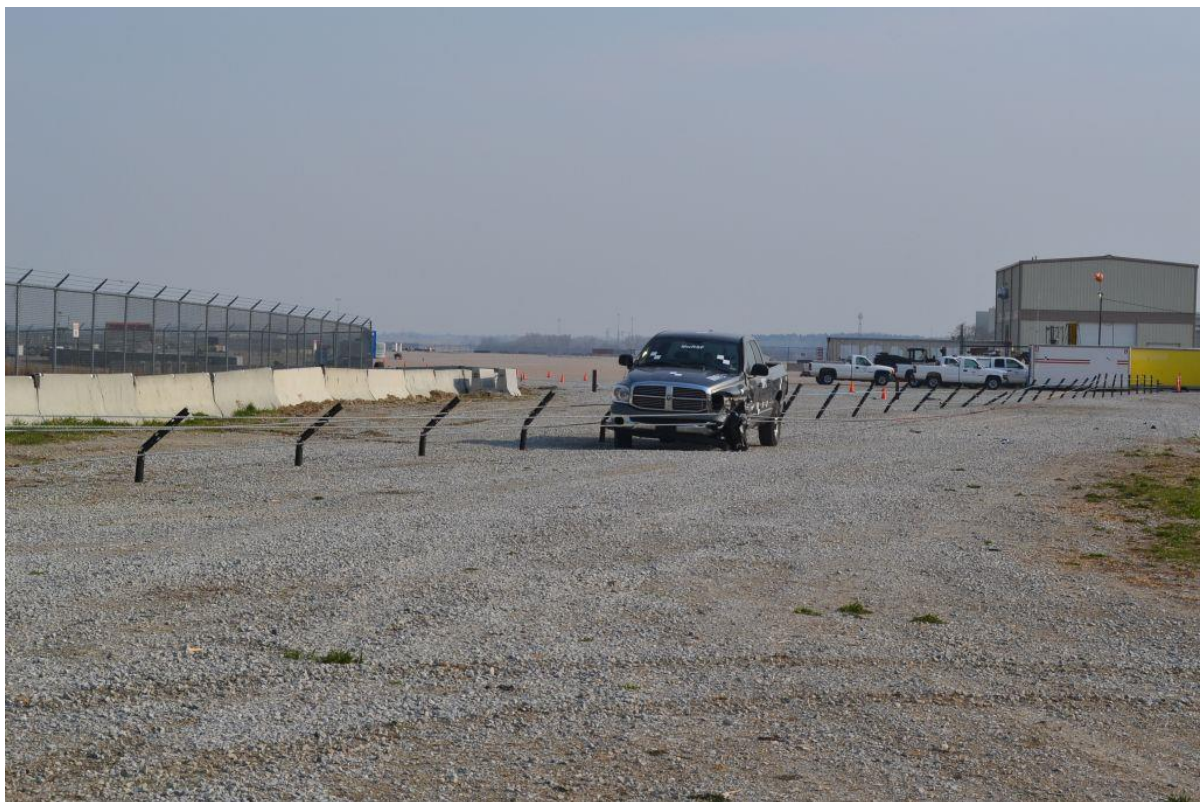
Figure 62. Impact Location, Test No. MWP-2

Initial vehicle impact was to occur 12 in. (305 mm) upstream from post no. 17, as shown in Figure 62, which was selected according to MASH. The actual point of impact was approximately 11 in. (279 mm) upstream from post no. 17. A sequential description of the impact events is contained in Table 10. The vehicle came to rest 187 ft – 1 in. (57.0 m) downstream from the point of impact and 4 ft – 1 in. (1.2 m) laterally behind the barrier's initial position after successfully being captured by the barrier system. The vehicle trajectory and final position are shown in Figures 56 and 63.

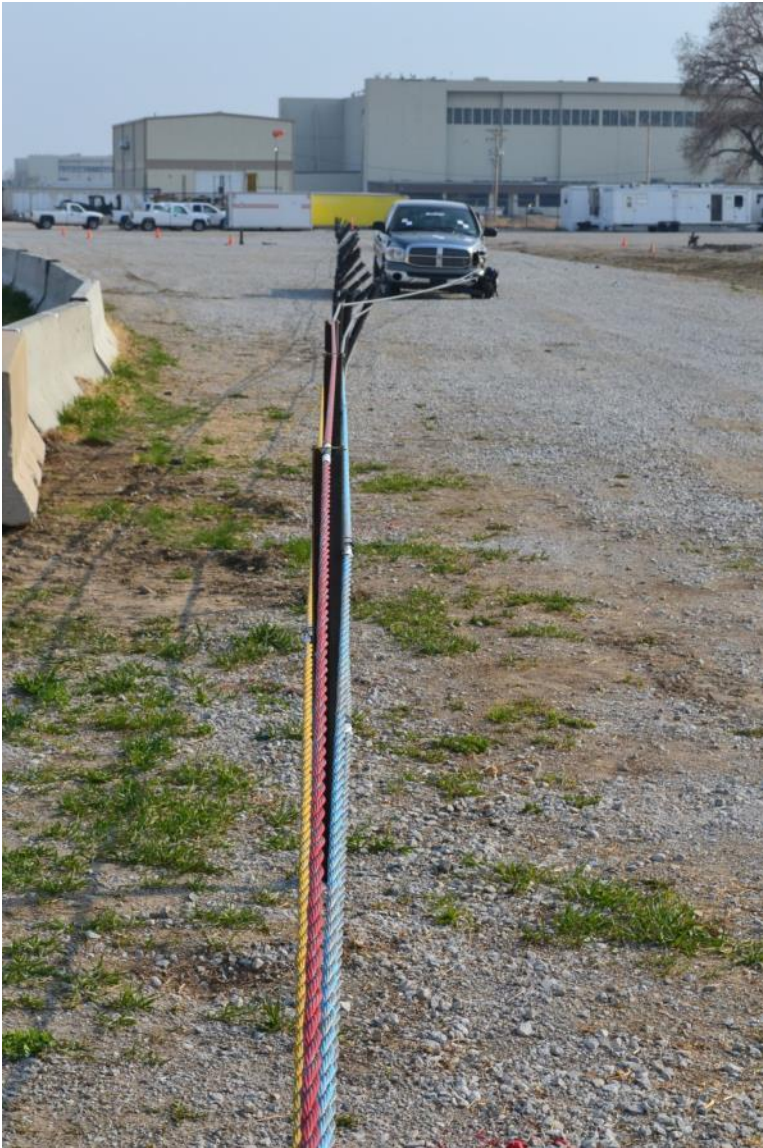
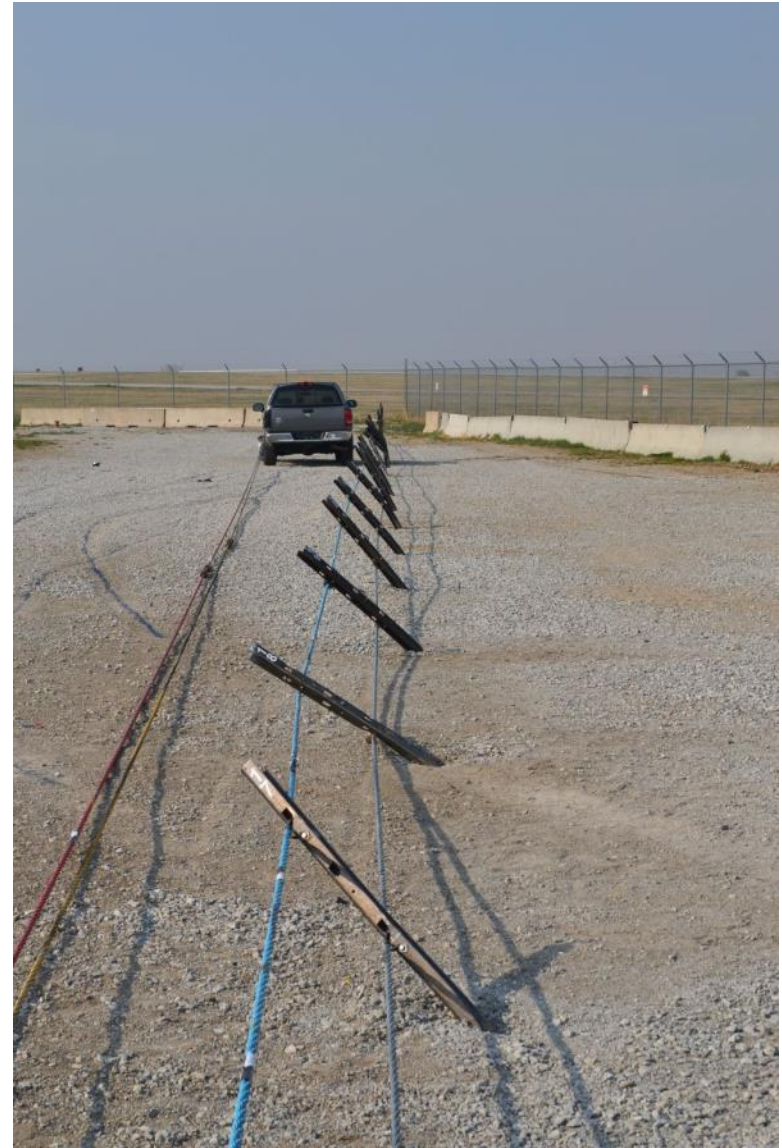
Figure 63. Vehicle Trajectory and Final Position, Test No. MWP-2

Damage to the barrier was moderate, as shown in Figures 63 through 66. Barrier damage consisted of bent posts, disengaged cables, deformed cable brackets, and movement of cable end anchor foundations. At the vehicle's final resting place it was still in contact with the system,

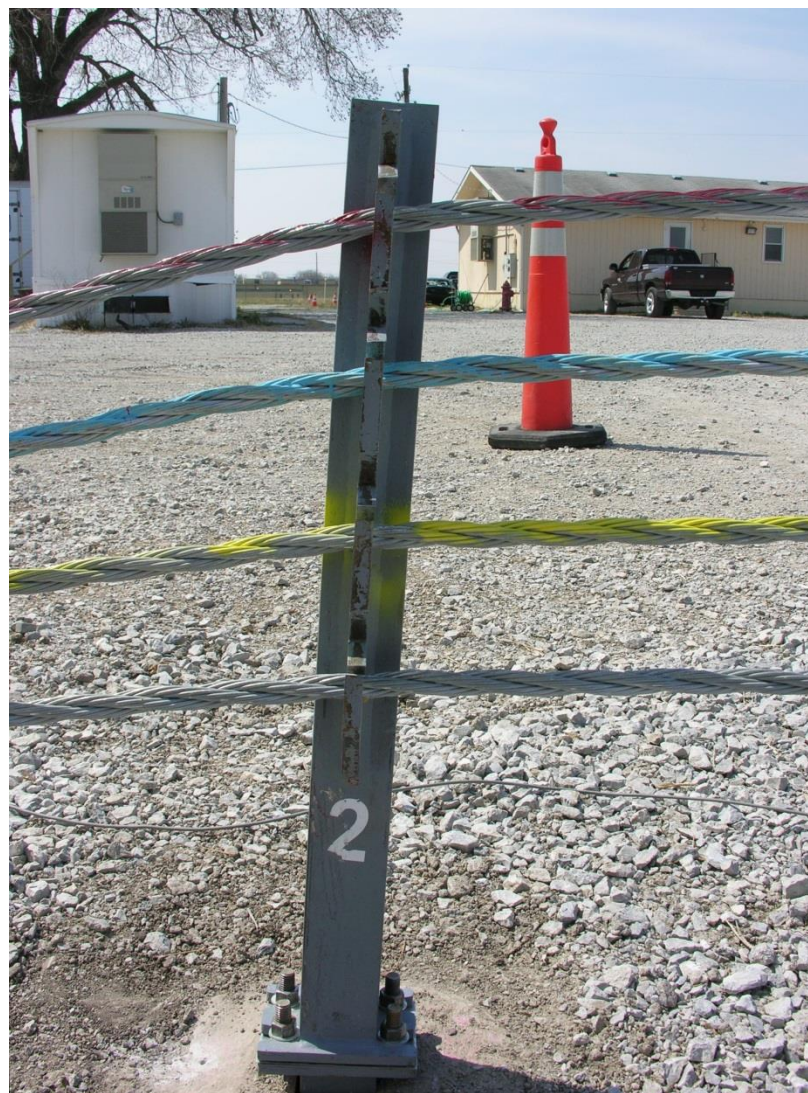
Post No. 2

Figure 65. Damage to Anchorages, Test No. MWP-2

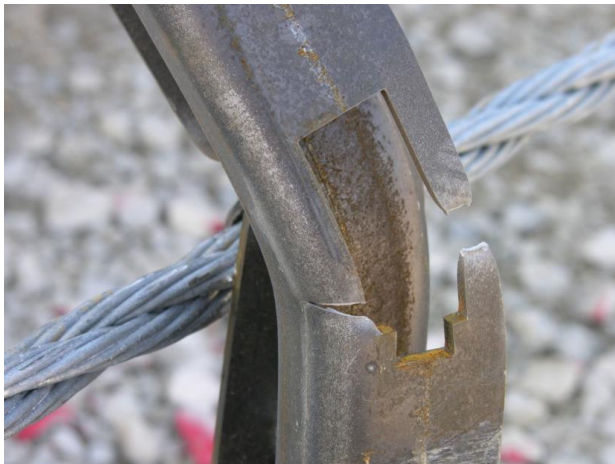
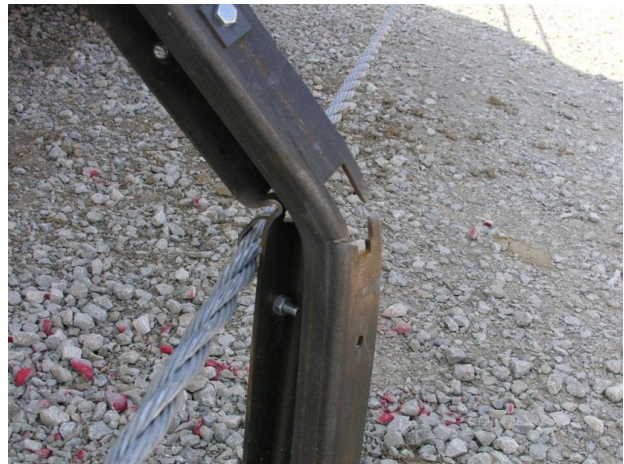
Post No. 28

Figure 66. Damage to Lower Keyhole, Post Nos. 27 through 29, Test No. MWP-2

Modifications were made to the system posts in order to prevent the MWPs from bending and tearing at the keyways for cable no. 1 as seen in test no. MWP-2. The keyways were adjusted so that each post contained only four keyways as opposed to the six seen in the previous tests. Three keyways were placed on one side of each post at the same heights used previously. However, the opposite side had only one keyway, located at the middle cable position. This modification eliminated the symmetry of the posts, but still allowed for median and roadside versions of the system (all cables on front) with a single post. The sizes of the keyways were also modified. The height of the upper portion of each keyway was reduced by $\frac{1}{4}$ in. (6 mm) to increase the buckling strength of the steel strip located between the keyway and the free edge of the post. This change was intended to increase bending strength in the post and prevent plastic hinges from forming around the first cable keyway. Based on analysis of previous bogie testing results, this reduced keyway height was determined to not affect the bracket exiting the keyway. Finally, the tops of the posts were extended $\frac{1}{4}$ in. (6 mm) to prevent damage to the brass rod installation slot in the post flange when driving the posts into the ground. During installation of the posts for test no. MWP-2 some of the slots closed slightly from the repeated impacts of the

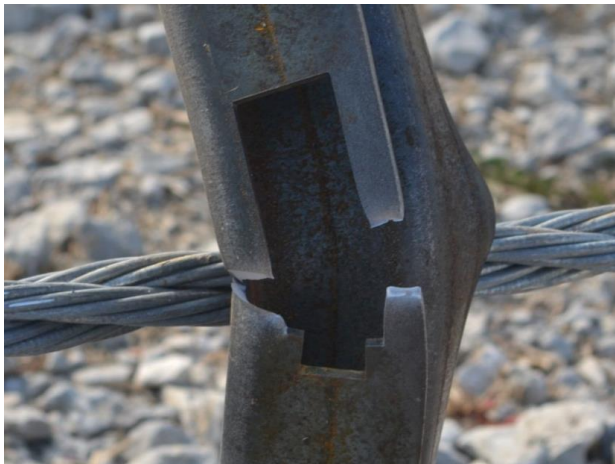
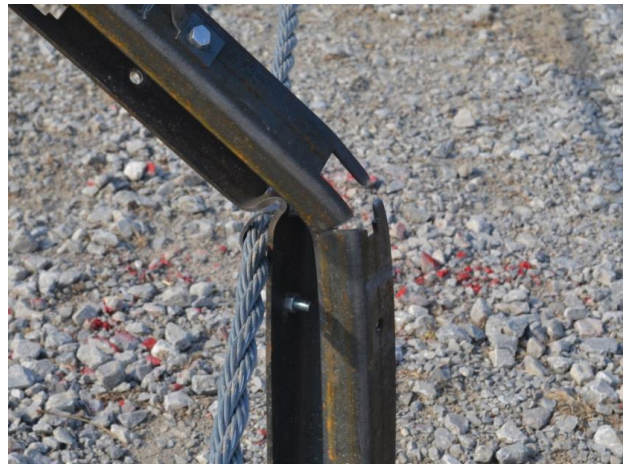
Post No. 31

Figure 67. Damage to Lower Keyhole, Post Nos. 30 through 32, Test No. MWP-2

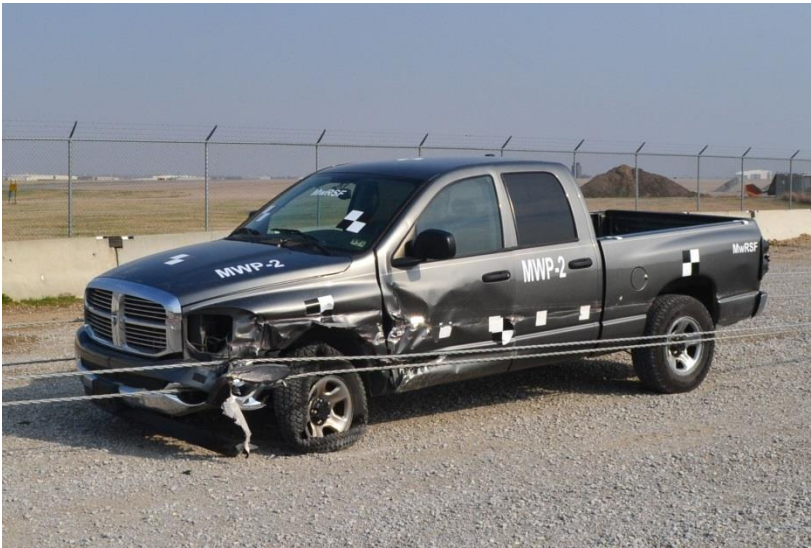
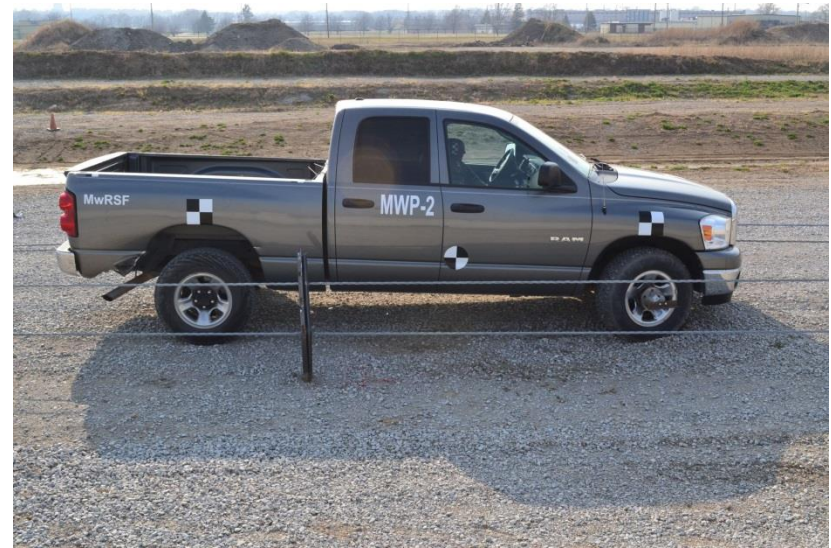
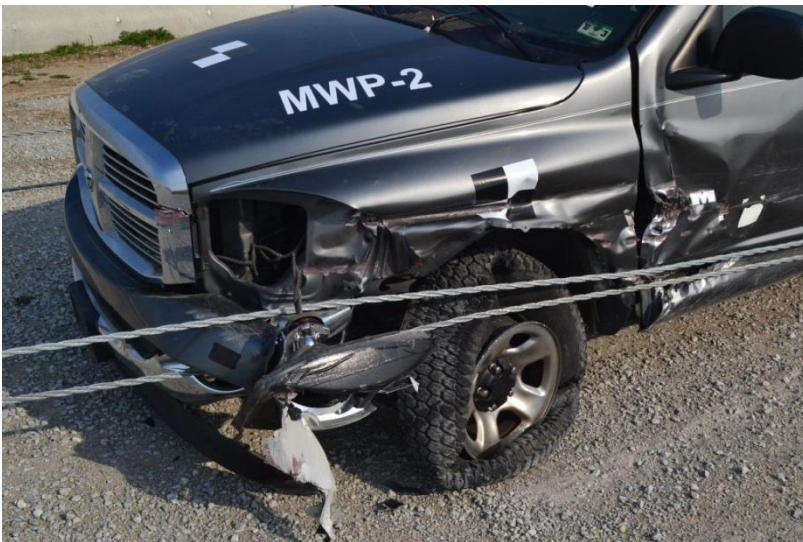
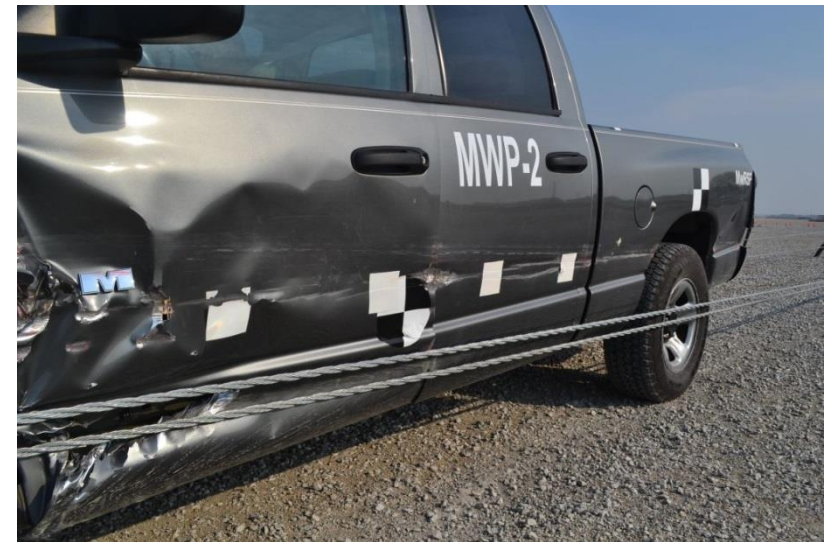
Figure 68. Vehicle Damage, Test No. MWP-2

The damage to the vehicle was moderate, as shown in Figure 68. The maximum occupant compartment deformations are listed in Table 11 along with the deformation limits established in MASH for various areas of the occupant compartment. Note that none of the MASH-established deformation limits were violated. Complete occupant compartment and vehicle deformations are provided in Appendix D.

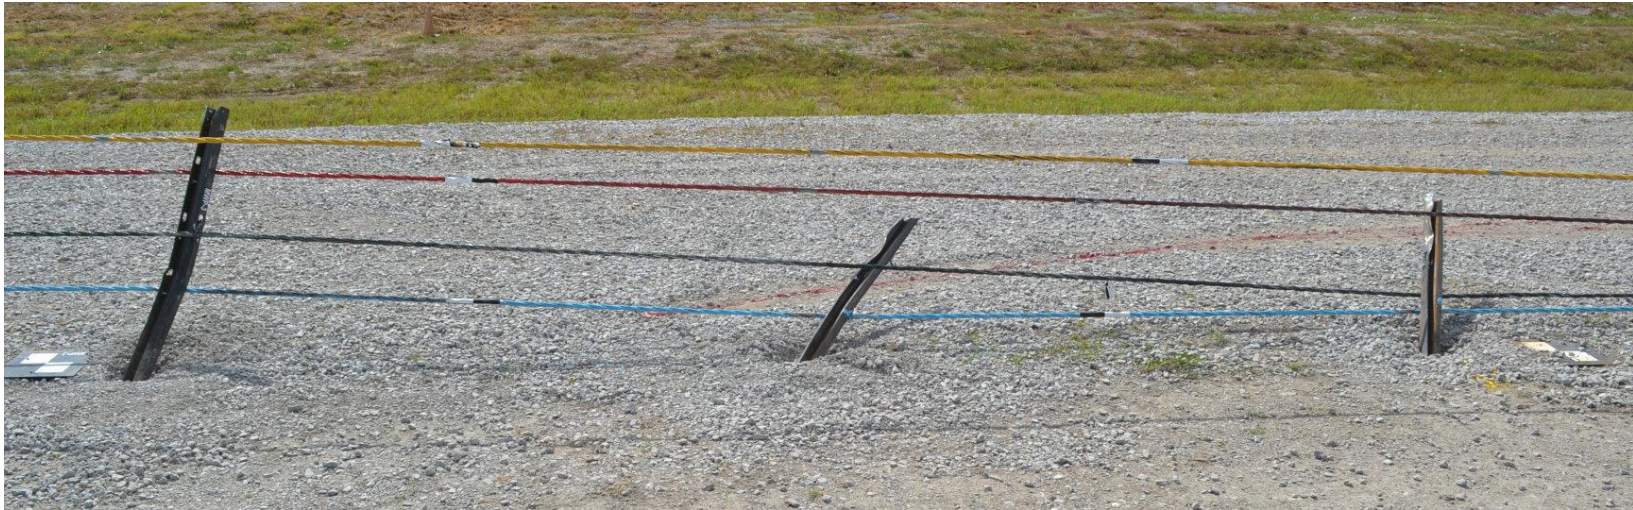
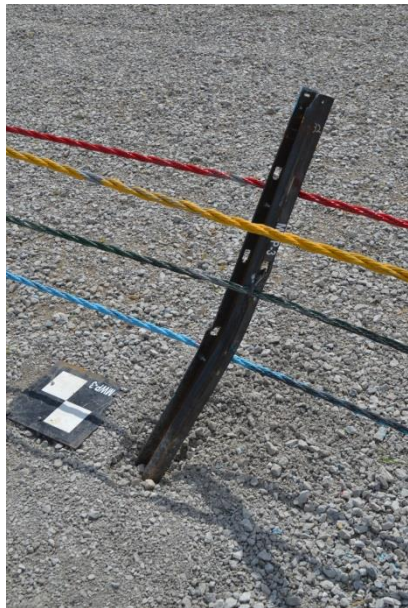
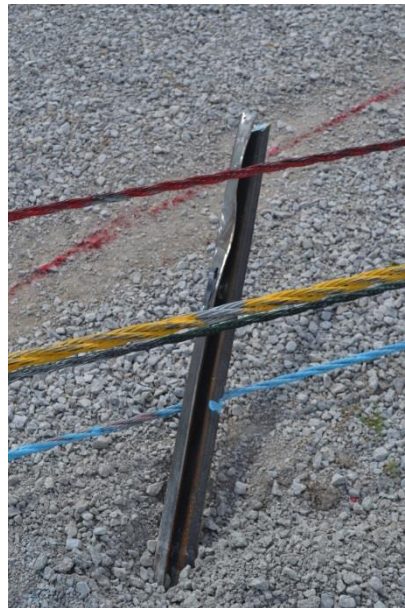
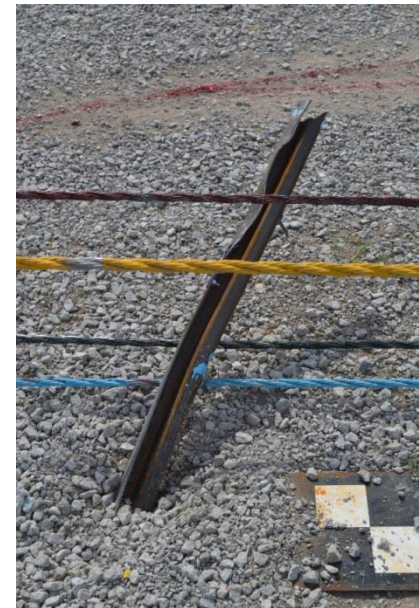
Figure 103. System Damage, Post Nos. 32 through 34, Test No. MWP-3

Damage to the barrier was moderate, as shown in Figures 103 through 108. Barrier damage consisted of bent posts, disengaged cables, and bent and fractured brackets. The concrete

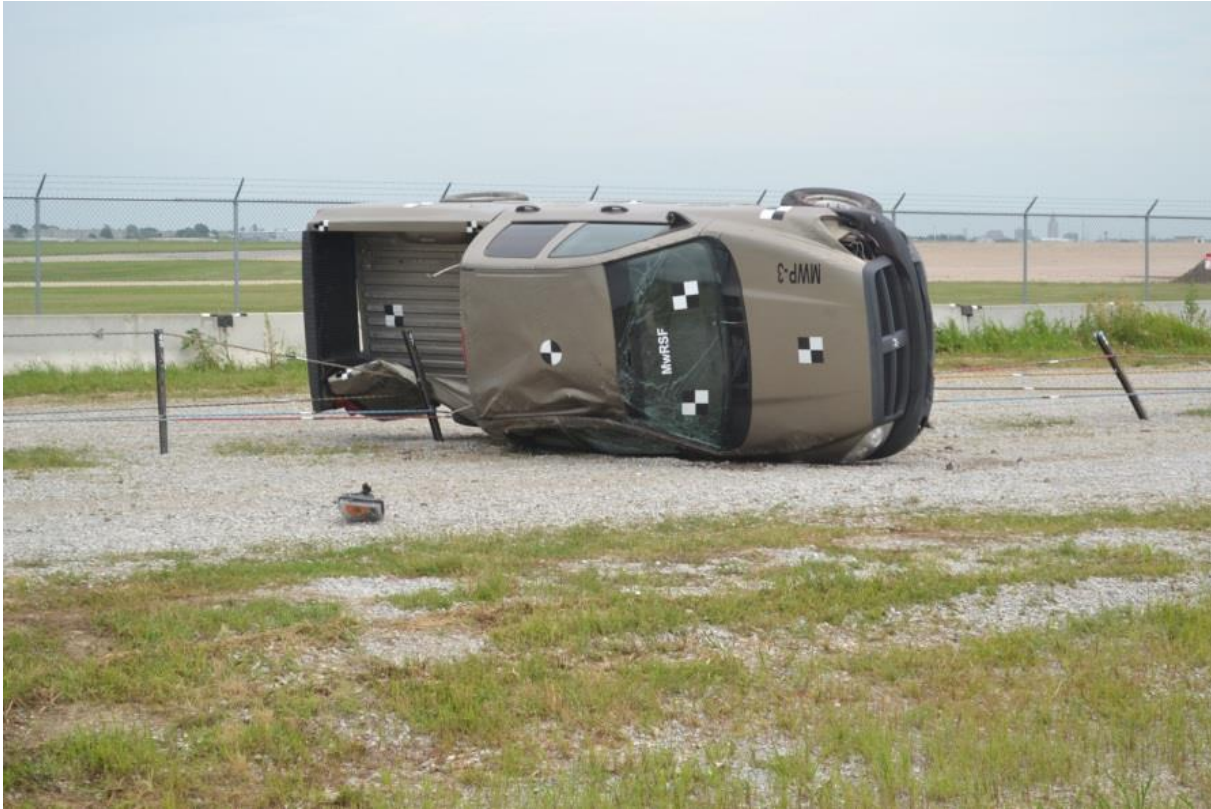
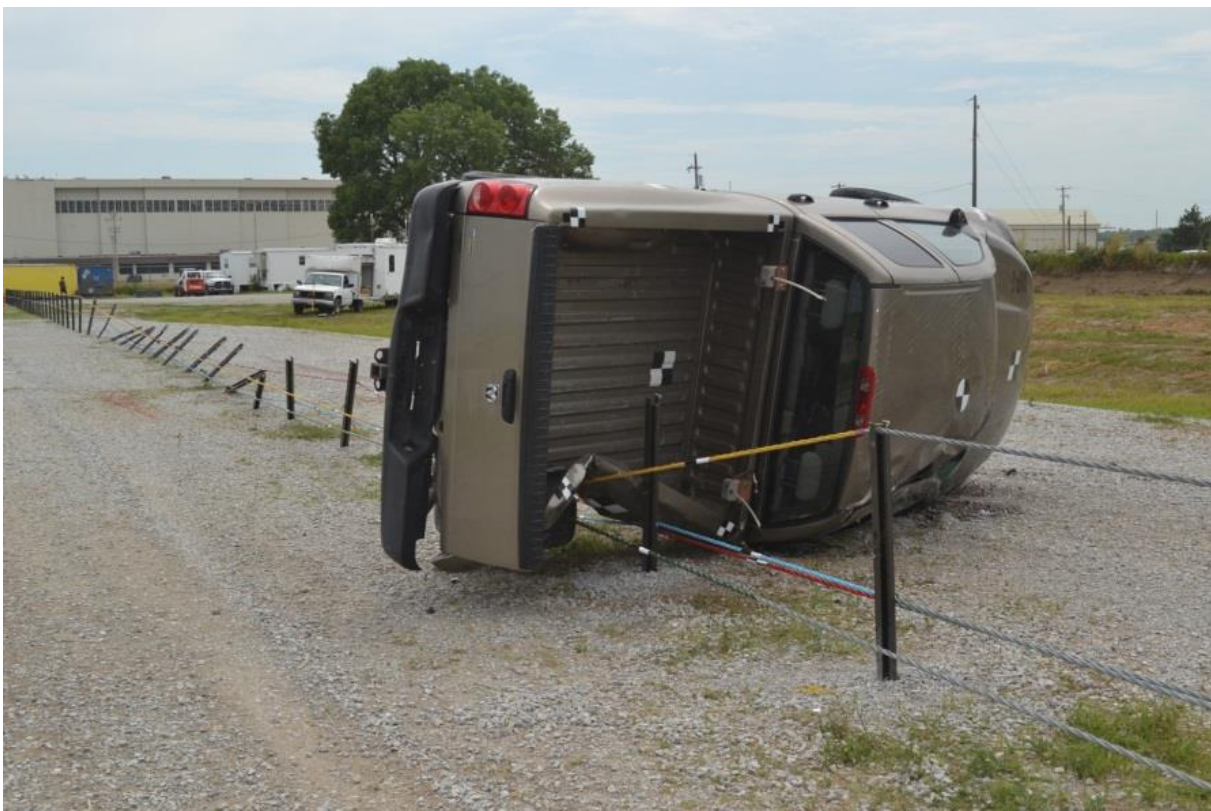
Figure 109. Vehicle Damage, Test No. MWP-3

The damage to the vehicle was extensive, as shown in Figures 109 and 110. The maximum occupant compartment deformations are listed in Table 16, along with the deformation limits established in MASH for various areas of the occupant compartment. Note that the MASH-established deformation limits for the roof were violated. Complete occupant compartment and vehicle deformations and the corresponding locations are provided in Appendix D.

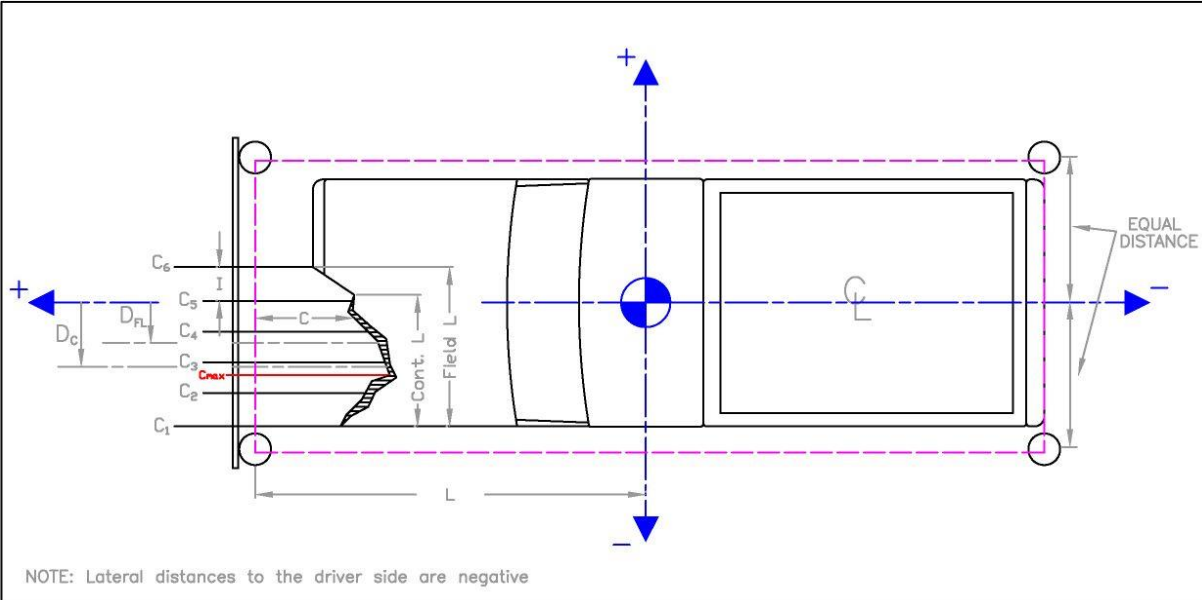
Figure D-17. Exterior Vehicle Crush (NASS) - Front, Test No. MWP-3

in.	(mm)
Distance from C.G. to reference line - L_{REF} :	108 1/4	(2750)
Width of contact and induced crush - Field L:	78	(1981)
Crush measurement spacing interval (L/5) - I:	15.6	(396)
Distance from center of vehicle to center of Field L - D_{FL} :	0	(0)
Width of Contact Damage:	78	(1981)
Distance from center of vehicle to center of contact damage - D_C :	0	(0)
